**Flood Control Project Maintenance
Levee Inspections**

Maintenance Issue Types Only, Levee Inspection Report By Mile - Fall 2016

Levee District No. 0001 (Sutter County)

Waterway	Bank	Unit Miles	Inspection Start/End	Inspector
Unit No. 01 Feather River	Right	16.11	10/04/2016 10/04/2016	Sterling York

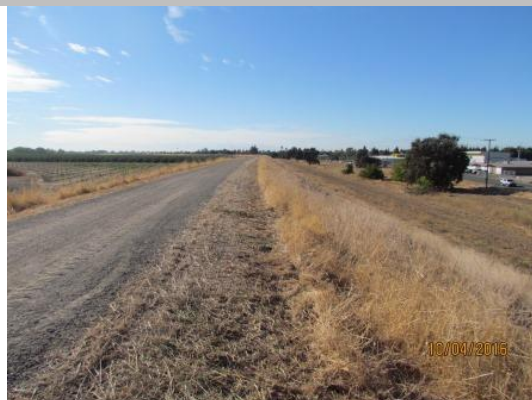
Photo 1 of 2 : FA_2016_LD0001S_433_30_20161007_00059.jpg

LM Start	0.01	Rating **	M	Issue No.	30
LM End	16.09	Issue Type +	Ma	Location *	LS
Category	Earthen Levee			GPS Latitude/Longitude	
				Start	End
Item	Vegetation			38.951109 °	39.168577 °
				-121.585711 °	-121.622691 °
DWR ID	DWR_LD0001S_01_f _ 2016_30				
Comment Code					
V1 : Control annual grass and weeds on the levee slopes and easements.					
Inspector Comment					
Annual grasses need to be maintained. Fall 2016.

View of annual grasses need to be maintained. Fall 2016.

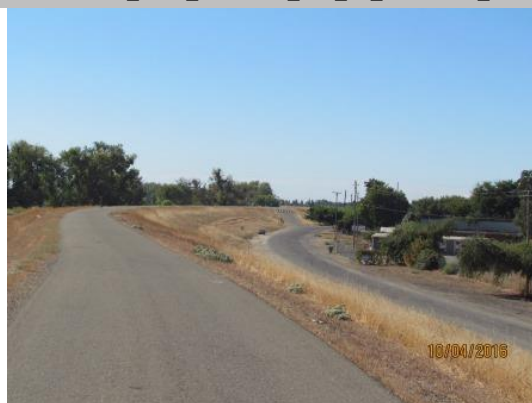
Photo 2 of 2 : FA_2016_LD0001S_433_30_20161007_00061.jpg

Second view of annual grasses need to be maintained. Fall 2016.

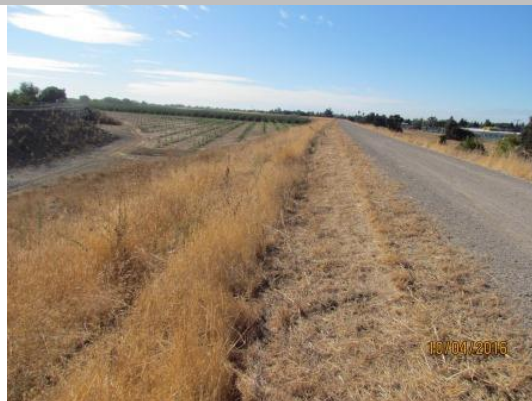
Photo 1 of 2 : FA_2016_LD0001S_433_31_20161007_00062.jpg

LM Start	0.01	Rating **	M	Issue No.	31
LM End	16.09	Issue Type +	Ma	Location *	WS
Category	Earthen Levee			GPS Latitude/Longitude	
				Start	End
Item	Vegetation			38.951109°	39.168577°
				-121.585711°	-121.622691°
DWR ID	DWR_LD0001S_01_f_2016_31				
Comment Code					
V1 : Control annual grass and weeds on the levee slopes and easements.					
Inspector Comment					
Annual grasses need to be maintained. Fall 2016.

View of annual grasses need to be maintained. Fall 2016.

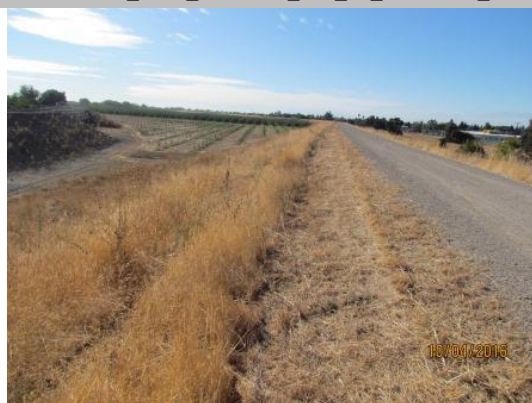
Photo 2 of 2 : FA_2016_LD0001S_433_31_20161007_00063.jpg

Second view of annual grasses need to be maintained. Fall 2016.

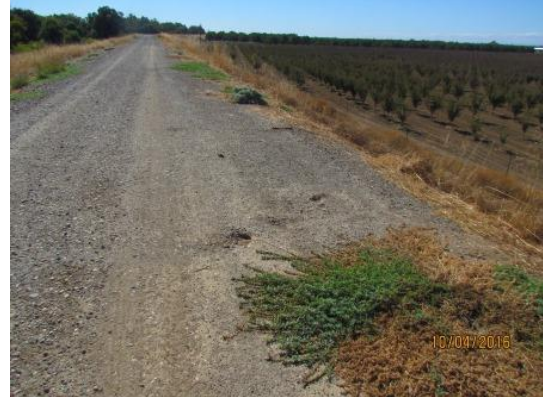
Photo 1 of 1 : FA_2016_LD0001S_433_17_20161007_00086.jpg

LM Start	2.72	Rating **	M	Issue No.	17
LM End	2.72	Issue Type +	Ma	Location *	CR
Category	Earthen Levee			GPS Latitude/Longitude	
				Start	End
Item	Animal Control			38.989470 °	38.989470 °
				-121.592502 °	-121.592502 °
DWR ID	DWR_LD0001S_01_s _ 2015_17				
Comment Code					
A3 : No rodents visible, but rodent burrows visible; need to backfill and compact or grout burrows.					
Inspector Comment

View of rodent holes on the landside crown and slope. Fall 2016.

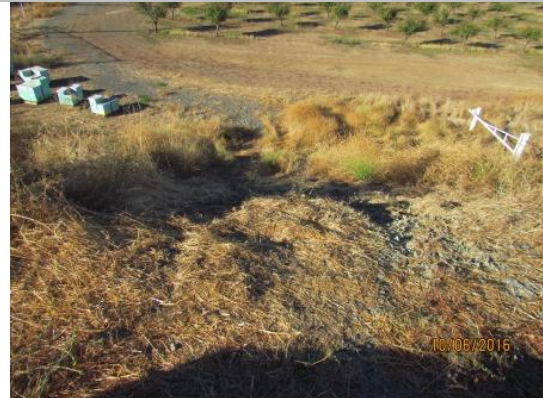
Photo 1 of 1 : FA_2016_LD0001S_433_21_20161007_00085.jpg

LM Start	4.41	Rating **	M	Issue No.	21
LM End	4.41	Issue Type +	Ma	Location *	LS
Category	Earthen Levee			GPS Latitude/Longitude	
				Start	End
Item	Slope Stability			39.011493 °	39.011493 °
				-121.603623 °	-121.603623 °
DWR ID	DWR_LD0001S_01_f_2016_21				
Comment Code					
S3 : Repair the levee slope damaged by vehicle traffic and prevent access where possible.					
Inspector Comment

View of landside slope where vehicles have been driving up and down to go around gate. Fall 2016.

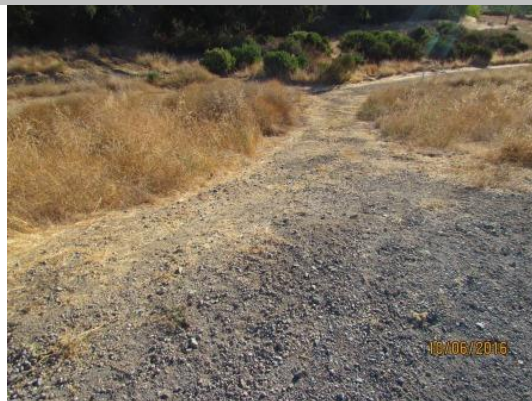
Photo 1 of 1 : FA_2016_LD0001S_433_36_20161007_00084.jpg

LM Start	4.41	Rating **	M	Issue No.	36
LM End	4.41	Issue Type +	Ma	Location *	WS
Category	Earthen Levee			GPS Latitude/Longitude	
				Start	End
Item	Slope Stability			39.011493°	39.011493°
				-121.603624°	-121.603624°
DWR ID	DWR_LD0001S_01_f_2016_36				
Comment Code					
S3 : Repair the levee slope damaged by vehicle traffic and prevent access where possible.					
Inspector Comment

View of waterside slope where vehicles have been driving up and down to go around gate. Fall 2016.

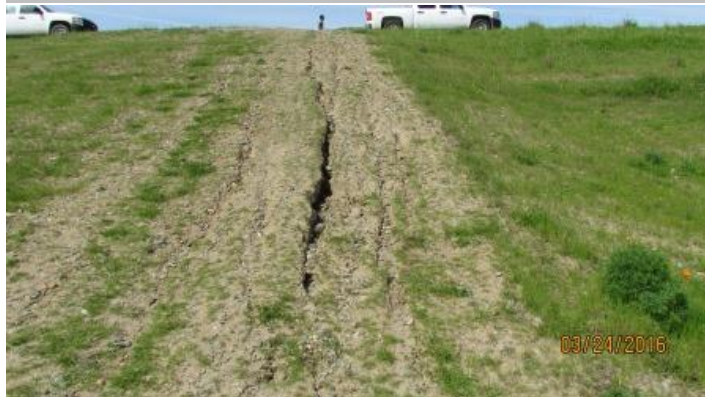
Photo 1 of 2 : FA_2016_LD0001S_433_42_20160906_00015.jpg

LM Start	11.63	Rating **	M	Issue No.	42
LM End	11.63	Issue Type +	Ma	Location *	WS
Category	Earthen Levee			GPS Latitude/Longitude	
				Start	End
Item	Slope Stability			39.109692°	39.109692°
				-121.607142°	-121.607142°
DWR ID	DWR_LD0001S_01_s_2016_42				
Comment Code					
S1 : Repair slope instability.					
Inspector Comment					
Erosion on the waterside slope caused by rain and foot traffic needs to be monitored. Fall 2016.

Slope erosion due to rain on the waterside. Spring 2016.

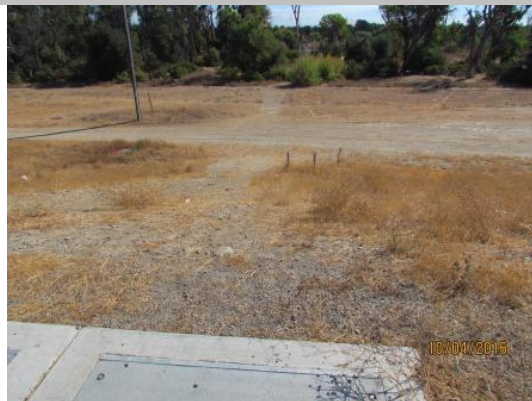
Photo 2 of 2 : FA_2016_LD0001S_433_42_20161007_00081.jpg

LM Start	11.63	Rating **	M	Issue No.	42 (cont)	
LM End	11.63	Issue Type +	Ma	Location *	WS	
Category	Earthen Levee			GPS Latitude/Longitude		
				Start		End
Item	Slope Stability			39.109692 °		39.109692 °
				-121.607142 °		-121.607142 °
DWR ID	DWR_LD0001S_01_s_2016_42					
Comment Code						
S1 : Repair slope instability.						
Inspector Comment						
Erosion on the waterside slope caused by rain and foot traffic needs to be monitored. Fall 2016.

View of were slope erosion due has occurred due to rain and foot traffic on the waterside. Fall 2016.

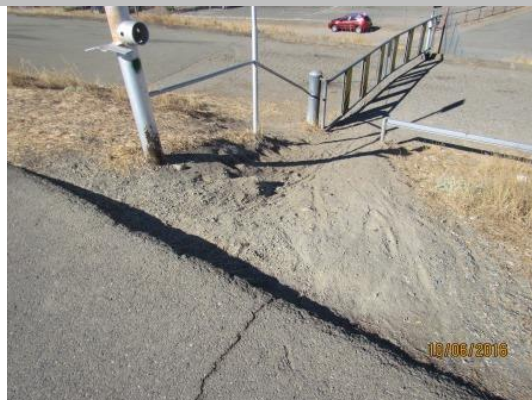
Photo 1 of 1 : FA_2016_LD0001S_433_40_20161007_00080.jpg

LM Start	12.28	Rating **	M	Issue No.	40
LM End	12.28	Issue Type +	Ma	Location *	WS
Category	Earthen Levee			GPS Latitude/Longitude	
				Start	End
Item	Slope Stability			39.118530 °	39.118530 °
				-121.603455 °	-121.603455 °
DWR ID	DWR_LD0001S_01_f_2016_40				
Comment Code					
S2 : Repair the levee slope damaged by foot traffic and prevent access where possible.					
Inspector Comment

View of landside slope at access gate that has been cut into by foot traffic. Fall 2016.

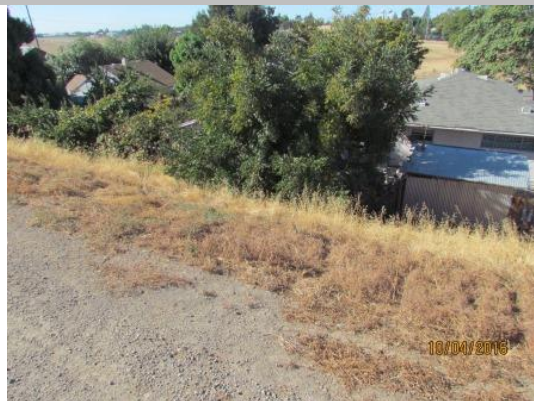
Photo 1 of 1 : FA_2016_LD0001S_433_27_20161007_00077.jpg

LM Start	13.25	Rating **	M	Issue No.	27
LM End	13.25	Issue Type +	Ma	Location *	LS
Category	Earthen Levee			GPS Latitude/Longitude	
				Start	End
Item	Trim / Thin Trees			39.131827 °	39.131827 °
				-121.603233 °	-121.603233 °
DWR ID	DWR_LD0001S_01_f_2015_27				
Comment Code					
T3 : Trim and thin trees to allow visibility of the ground and room to flood fight.					
Inspector Comment					
Tree foliage hiding levee face/toe. Fall 2016.

Tree at landside levee toe obstructing visibility. Fall 2016.

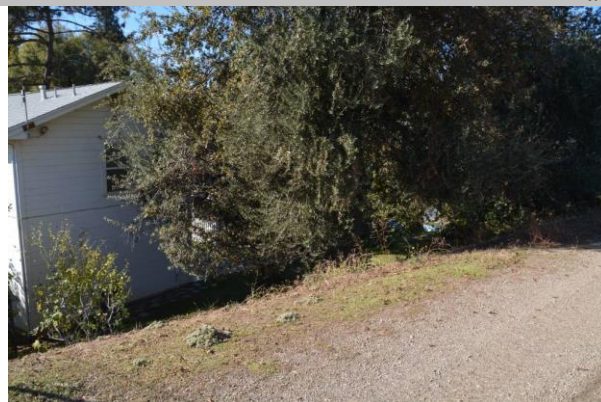
Photo 1 of 2 : FA_2016_LD0001S_433_18_20160906_00007.jpg

LM Start	13.34	Rating **	U	Issue No.	18
LM End	13.34	Issue Type +	Ma	Location *	LS
Category	Earthen Levee			GPS Latitude/Longitude	
				Start	End
Item	Vegetation			39.133050 °	39.133050 °
				-121.603813 °	-121.603813 °
DWR ID	DWR_LD0001S_01_f_2015_18				
Comment Code					
V7 : Trees / Woody Vegetation					
Inspector Comment					
Overgrown olive trees (6), buckeye (1) and oak trees (2) on slope of levee, branches touching and obscuring levee. Ivy obscuring slope.

Trees and vegetation blocking visibility. Spring 2016.

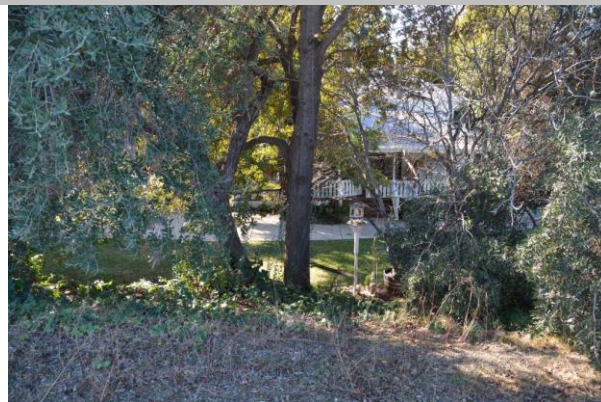
Photo 2 of 2 : FA_2016_LD0001S_433_18_20160906_00008.jpg

Trees and vegetation blocking visibility on the landside slope of the levee. Spring 2016.

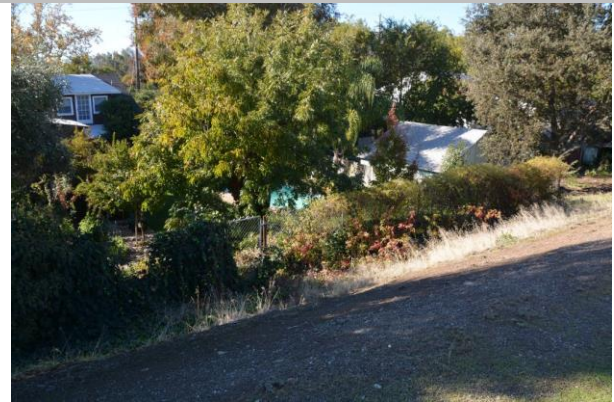
Photo 1 of 2 : FA_2016_LD0001S_433_24_20160906_00011.jpg

LM Start	13.42	Rating **	U	Issue No.	24
LM End	13.42	Issue Type +	Ma	Location *	LS
Category	Earthen Levee			GPS Latitude/Longitude	
				Start	End
Item	Vegetation			39.134119 °	39.134119 °
				-121.604213 °	-121.604213 °
DWR ID	DWR_LD0001S_01_f _ 2015_24				
Comment Code					
V7 : Trees / Woody Vegetation					
Inspector Comment					
Vegetation on the chainlink fence obscuring visibility. Oleander on the levee.

Trees and vegetation blocking visibility on the landside toe of the levee. Spring 2016.

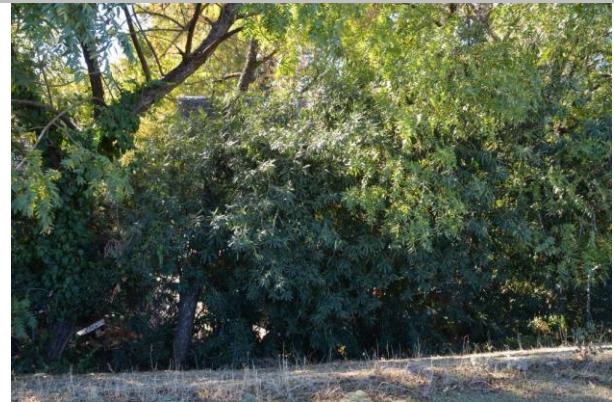
Photo 2 of 2 : FA_2016_LD0001S_433_24_20160906_00012.jpg

Trees and vegetation blocking visibility. Spring 2016.
